# Status and trend monitoring and evaluation in the Tahoe Basin

DAN SEGAN  
PRINCIPAL NATURAL RESOURCE ANALYST  
TAHOE REGIONAL PLANNING AGENCY  
JUNE 28, 2019

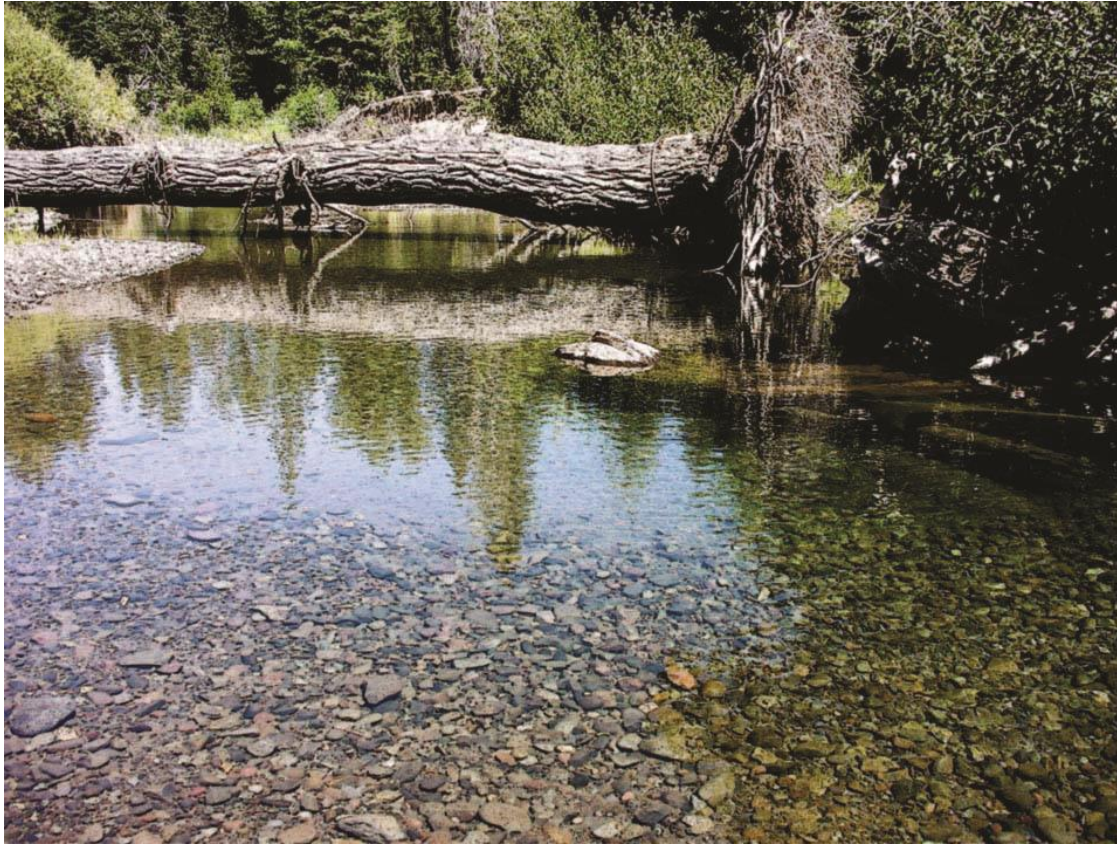
# Streams

## First flow-weighted load analysis

- 54.1% reduction in suspended sediment (~30 years)
- 38.6% reduction in phosphorus (~30 years)
- No change in total nitrogen
- 52.1% reduction in nitrate
- No change in FSP (~10 years)
