# Status and trend monitoring and evaluation in the Tahoe Basin

DAN SEGAN  
PRINCIPAL NATURAL RESOURCE ANALYST  
TAHOE REGIONAL PLANNING AGENCY  
JUNE 29, 2018

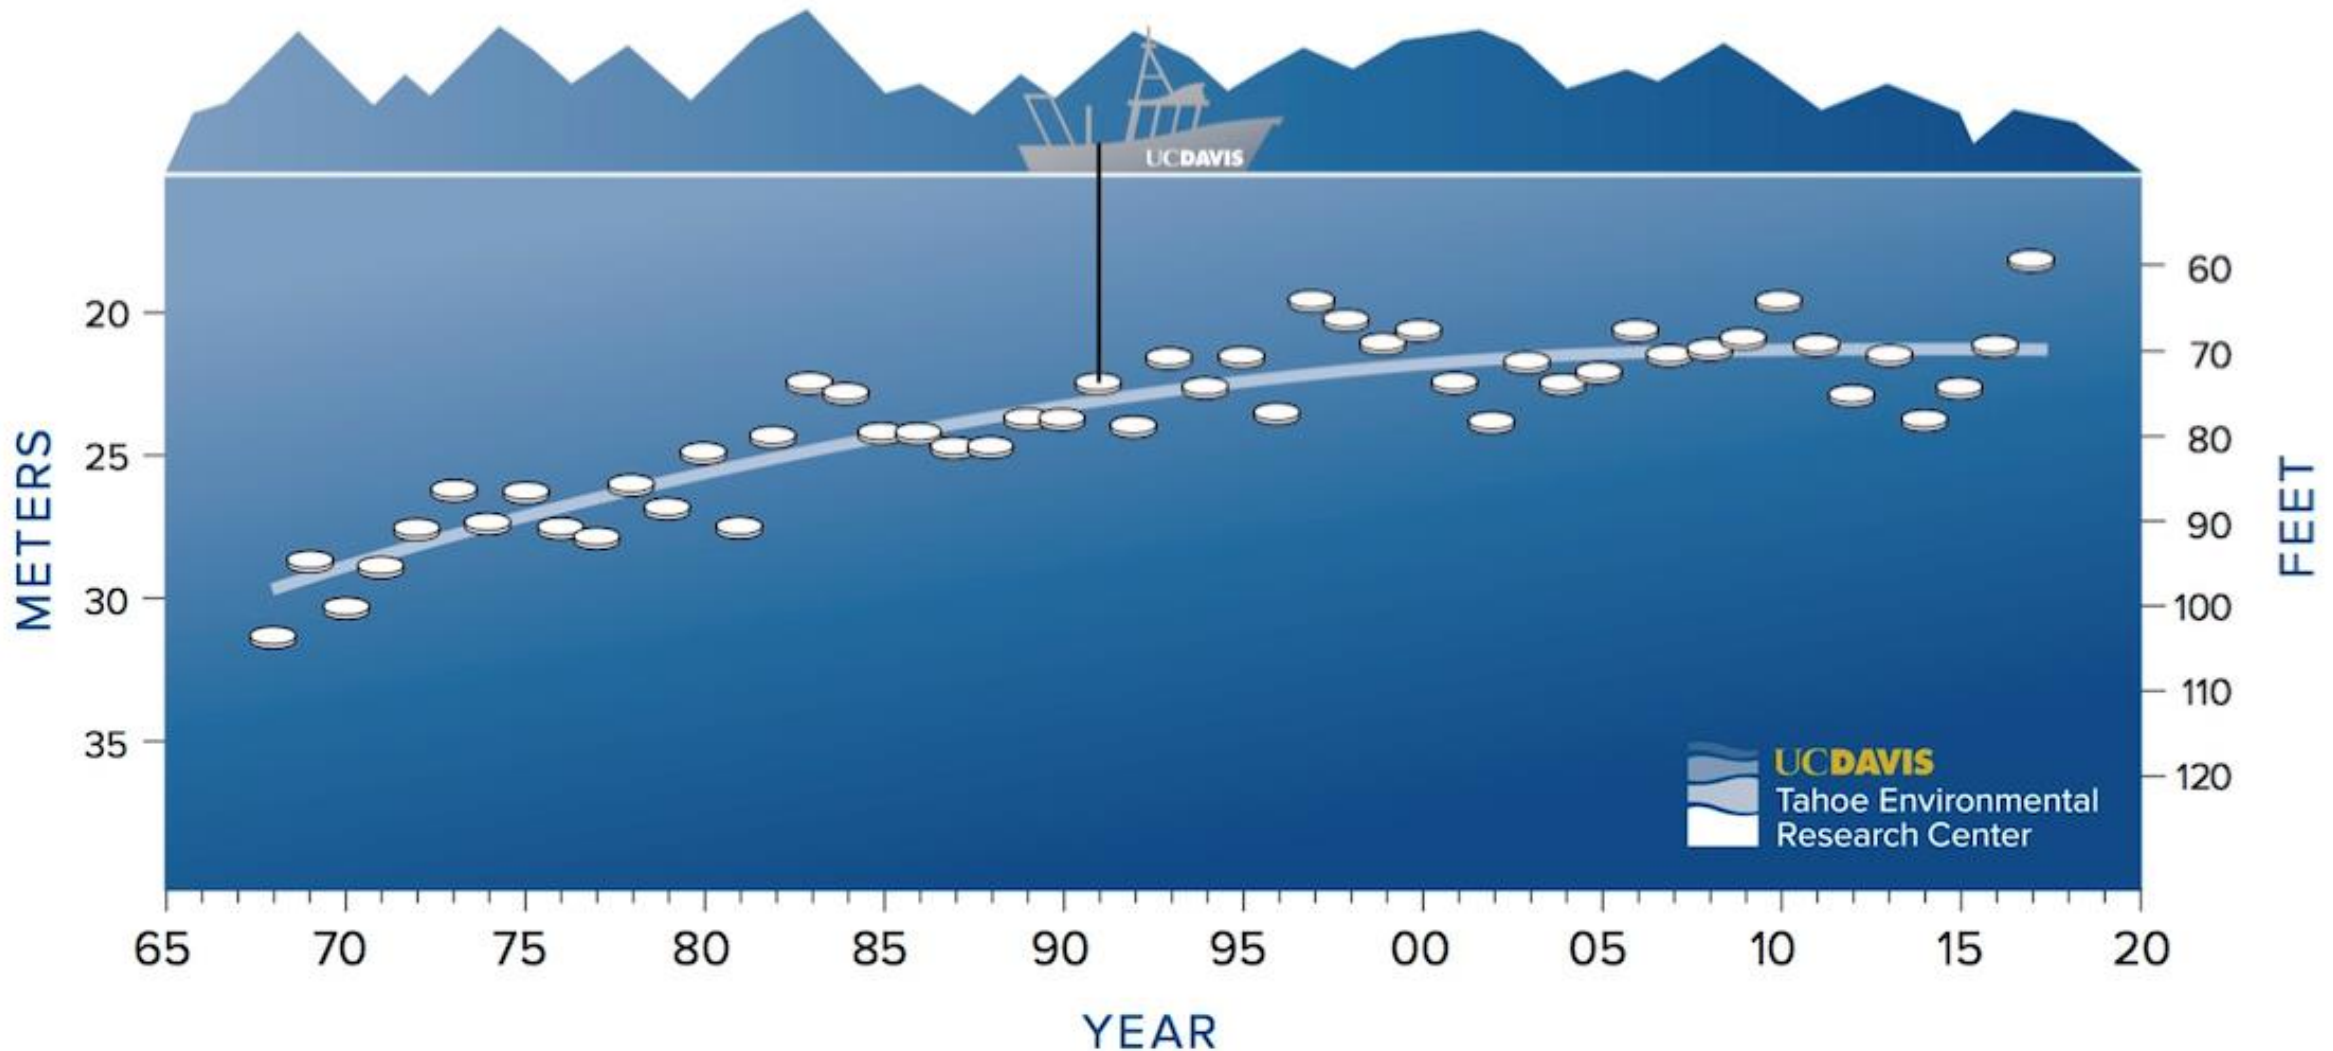
# ANNUAL AVERAGE SECCHI DEPTH

UCDAVIS  
Tahoe Environmental Research Center

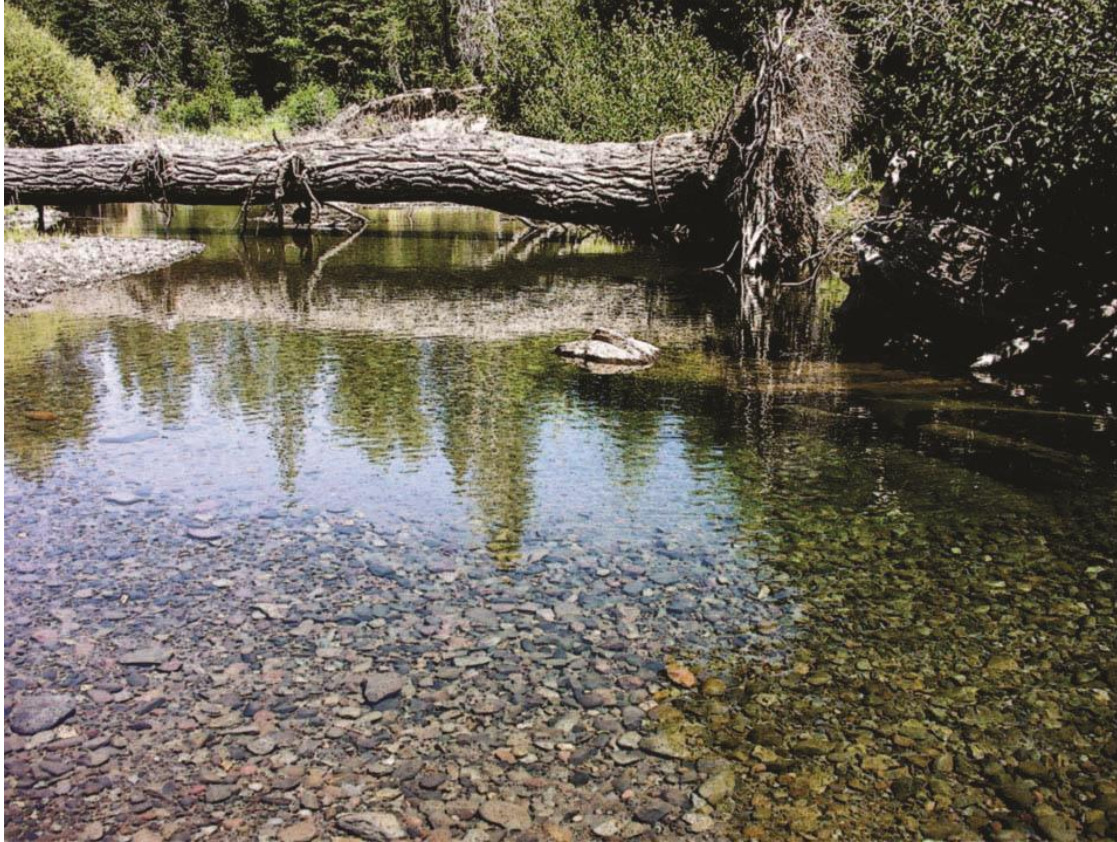
# Streams

## First flow-weighted load analysis

- 54.1% reduction in suspended sediment (~30 years)
- 38.6% reduction in phosphorus (~30 years)
- No change in total nitrogen
- 52.1% reduction in nitrate
- No change in FSP (~10 years)

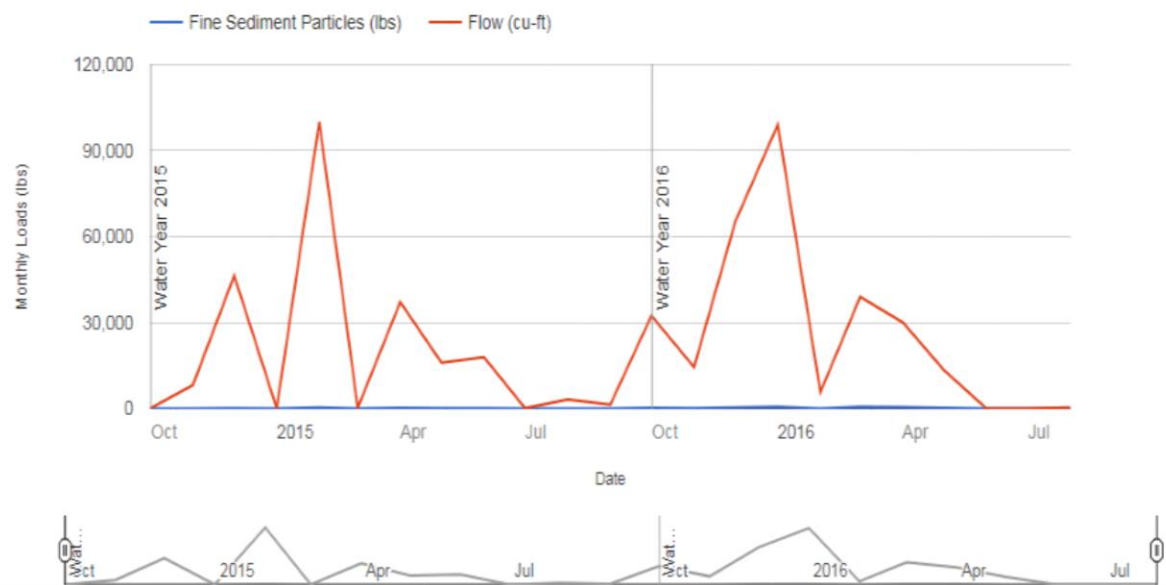
MONTHLY FLOW AND FINE SEDIMENT PARTICLE (FSP) LOAD SUMMARY

**Name** Speedboat Outfall  
**Abbreviation** SB  
**Description** Stormwater Outfall. Equipment includes a Palmer-Bowlus flume installed in a 24-inch culvert pipe with a 730 ISCO Bubbler to measure water level, an FTS DTS-12 turbidimeter to measure turbidity, an ISCO 6712 automated sampler to collect samples during storm events, and a Campbell Scientific CR1000 datalogger and Sierra Wireless RV50 modem for remote connectivity to equipment.

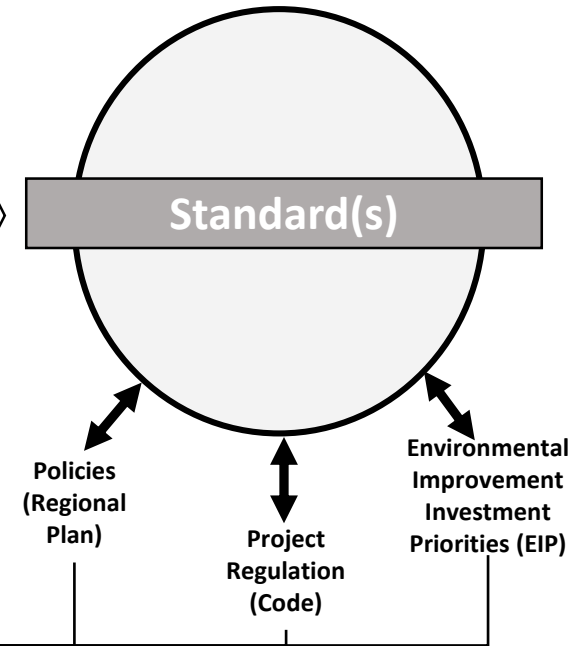
## Standards System

Management of system to achieve desired outcomes through standards expressed in policy, regulations, and investment priorities (Public Input)
