2014 Drought Operations Central Valley Project

U.S. Department of the Interior
Bureau of Reclamation

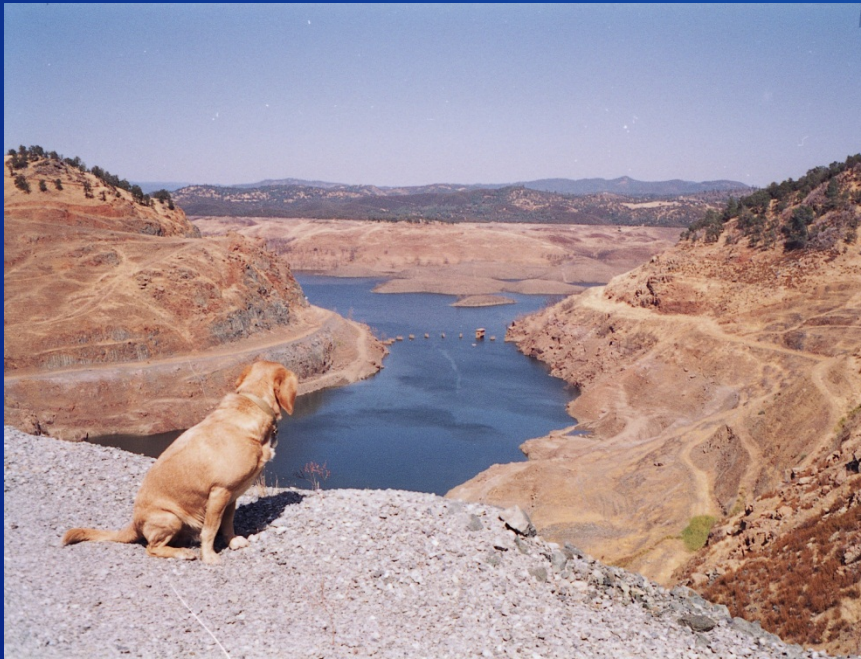
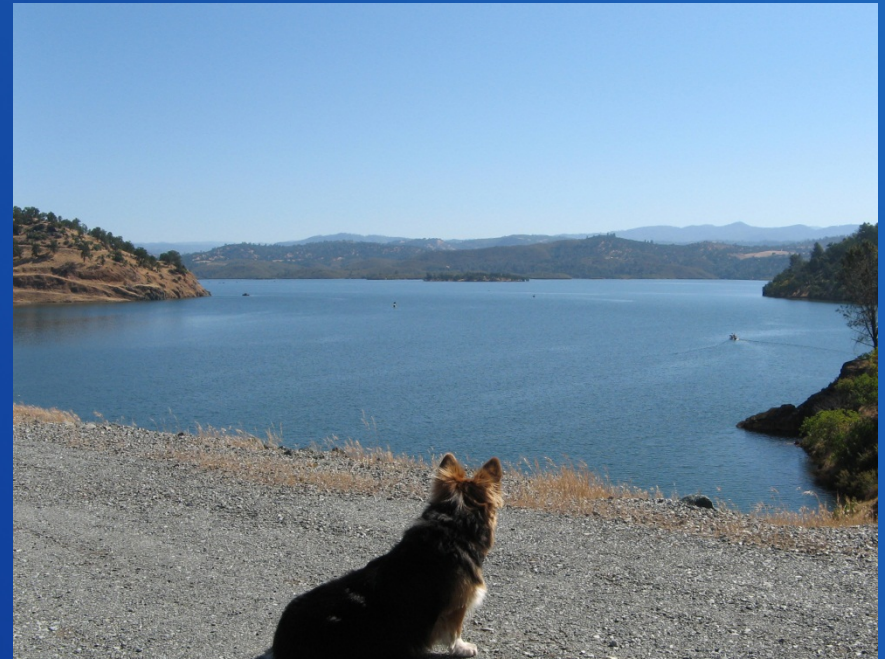
New Melones Reservoir September 1992 and June 2006

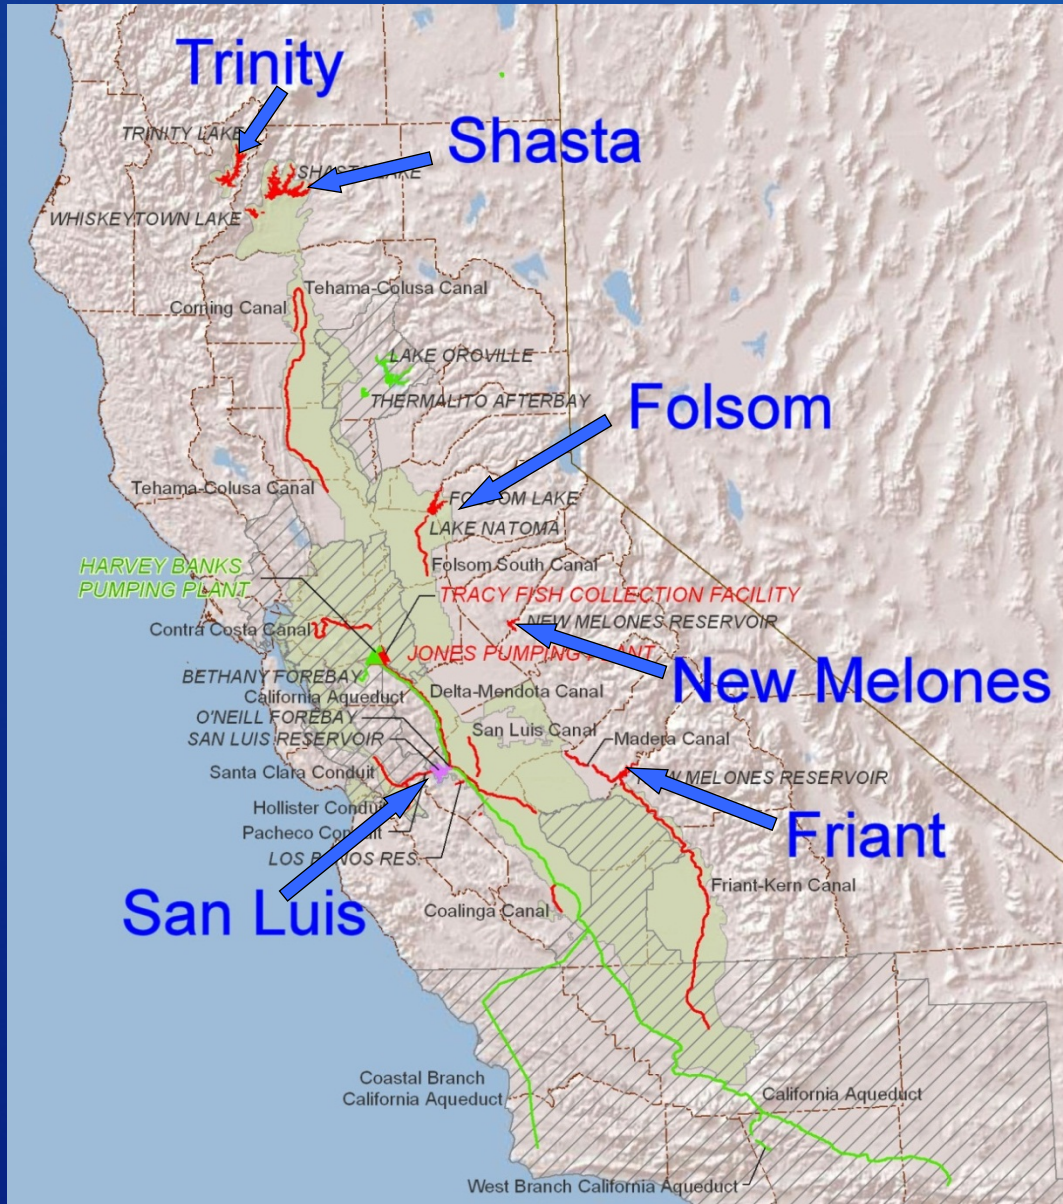
CVP Major Storage Facilities

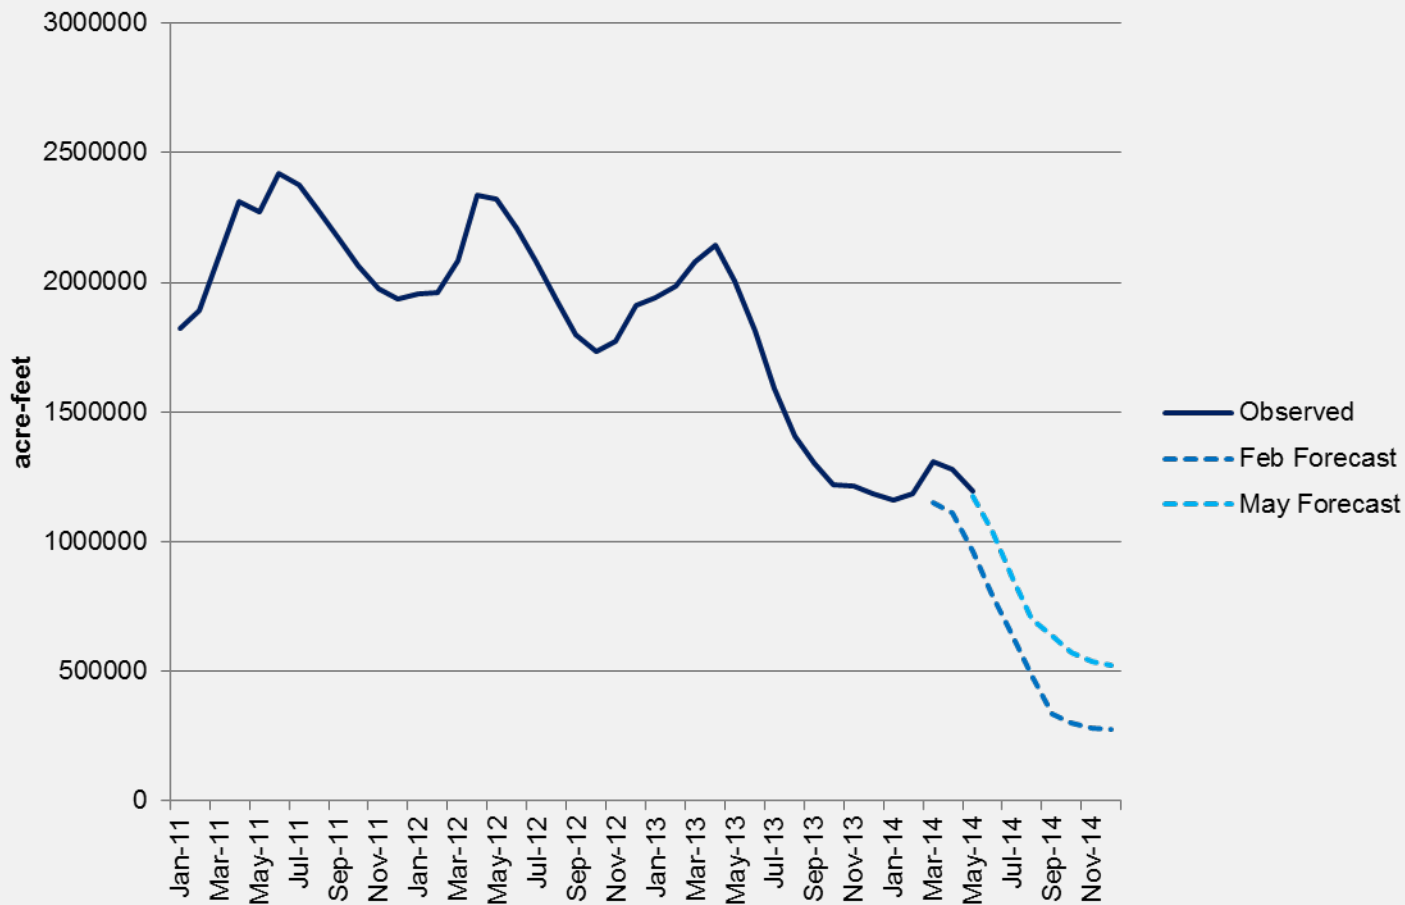
Trinity Storage

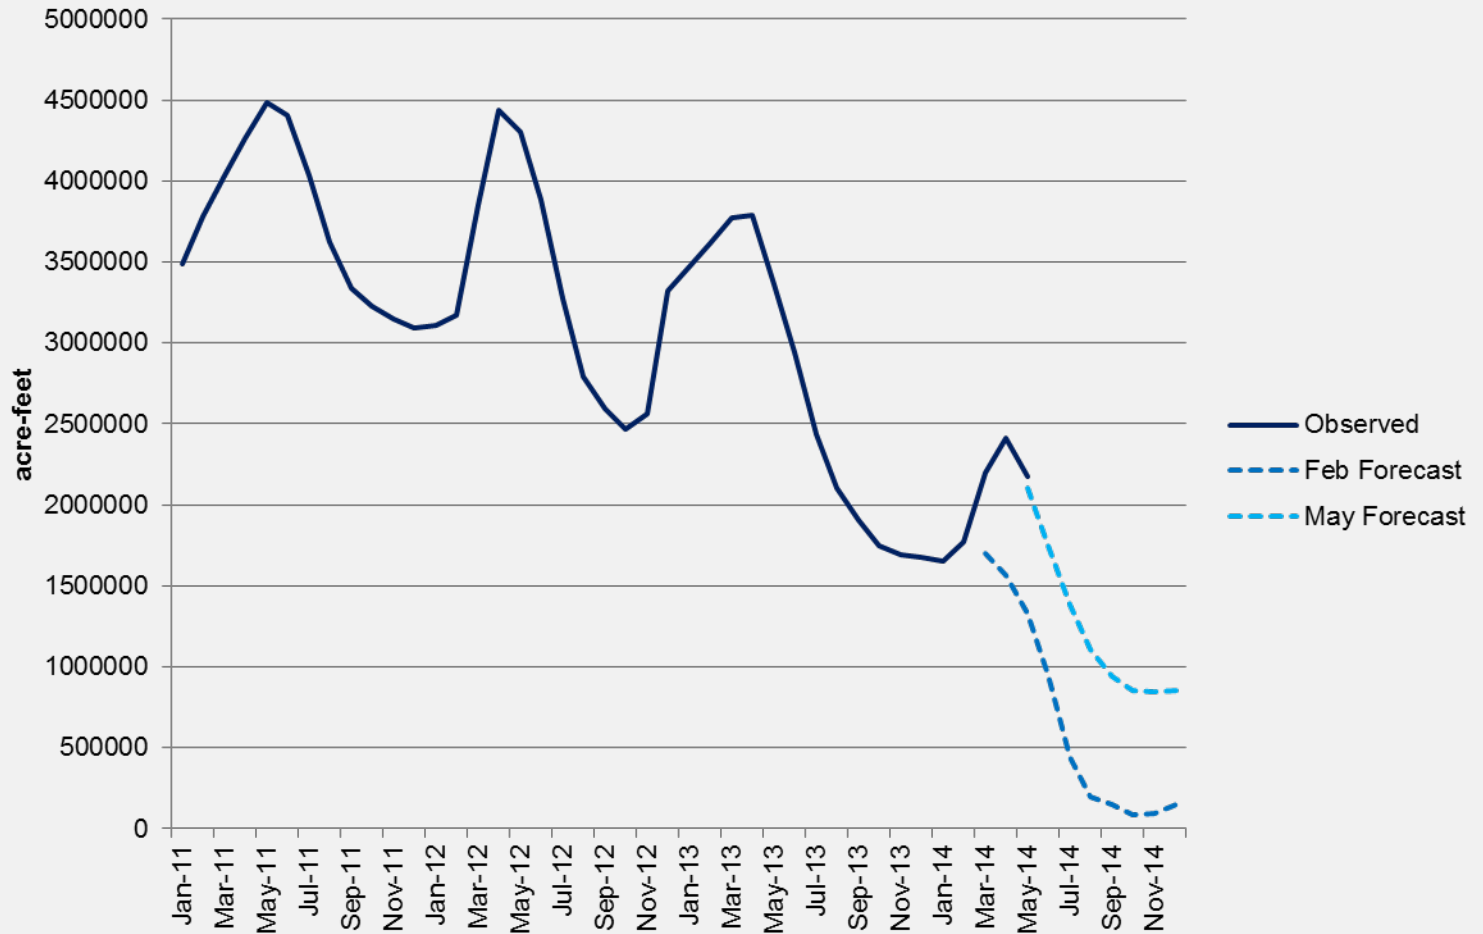
Shasta Storage

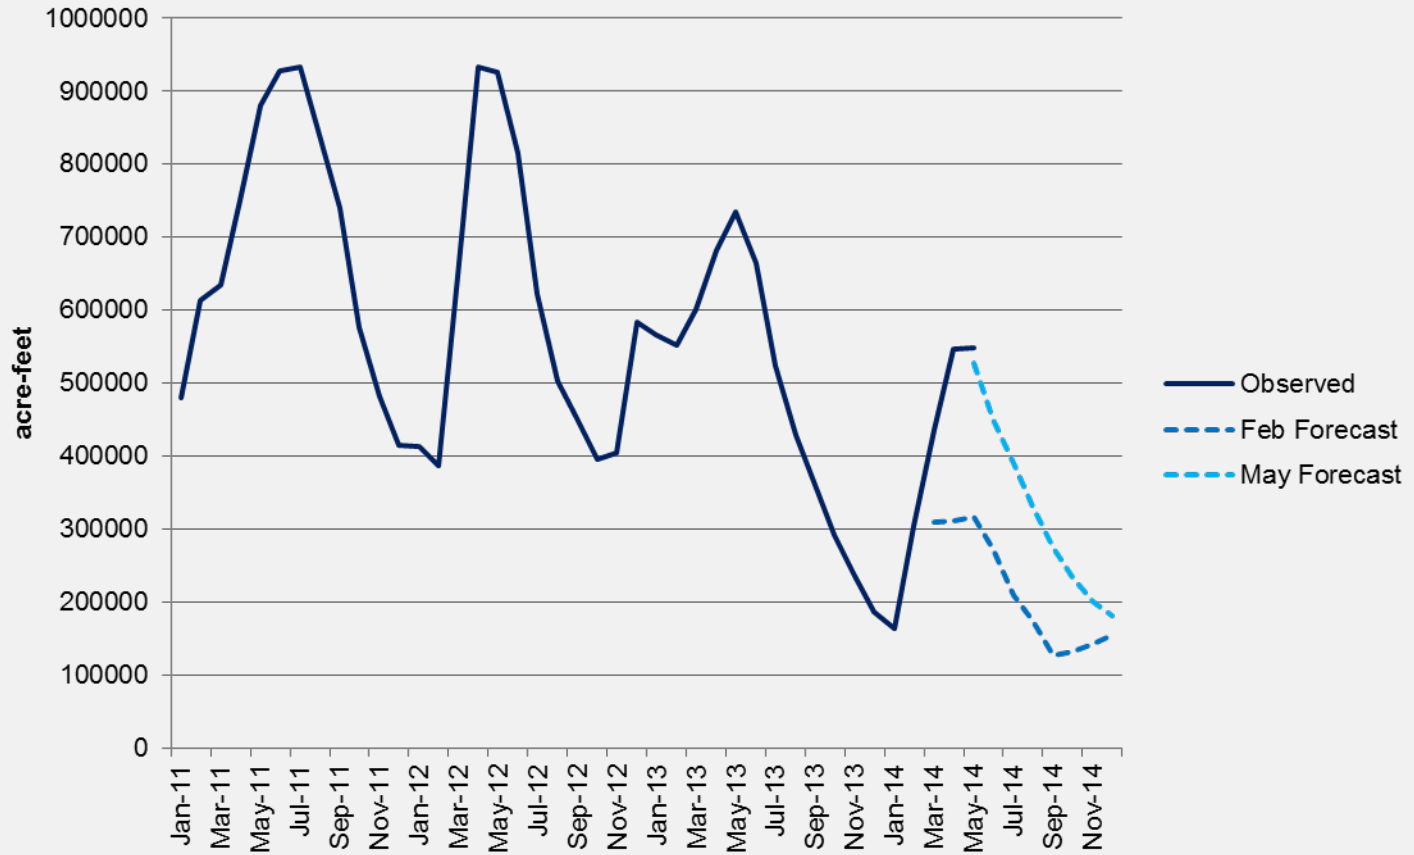
Folsom Storage

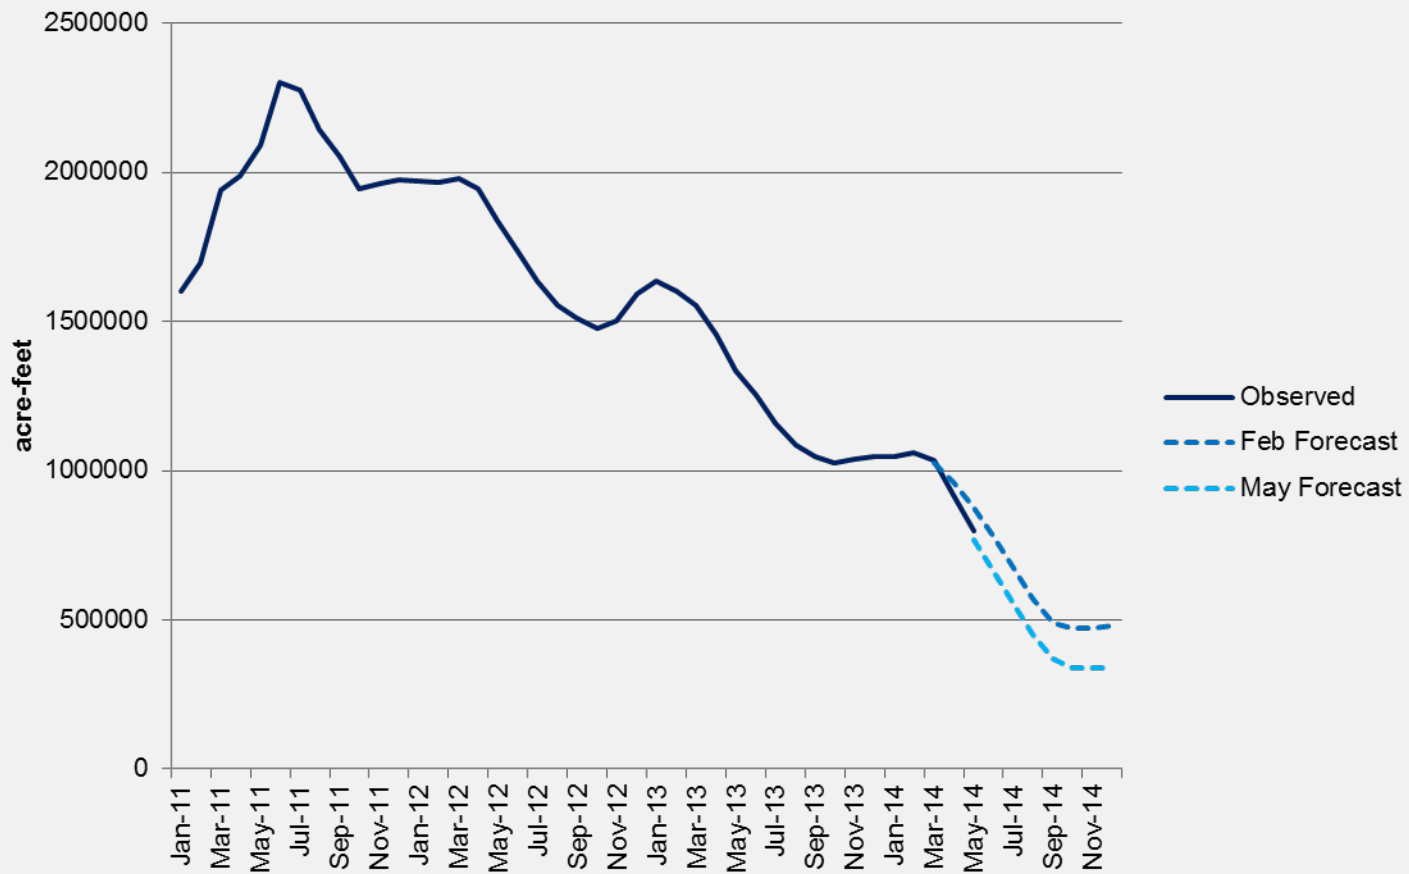
New Melones Storage

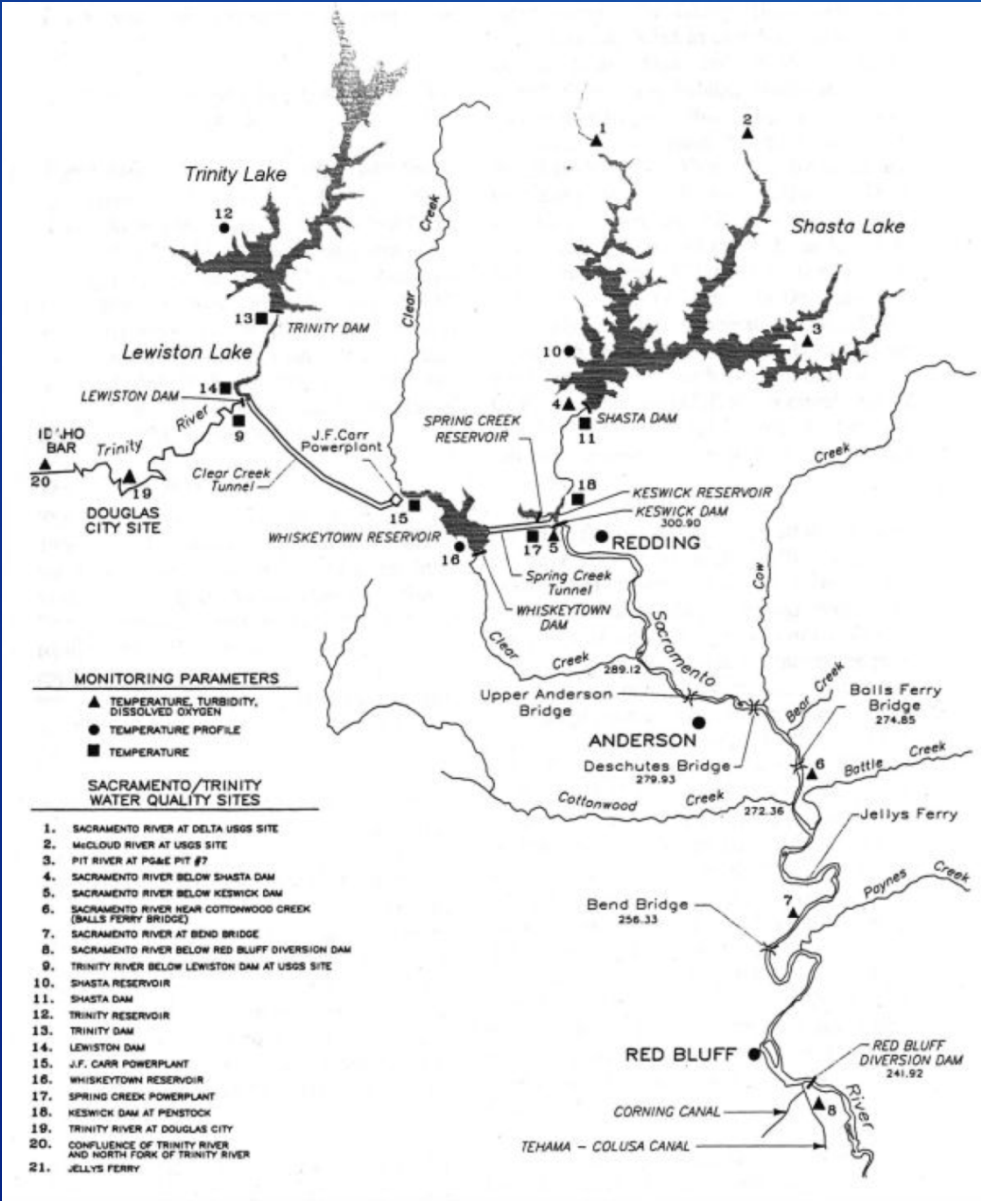
Sacramento River Temperature Control

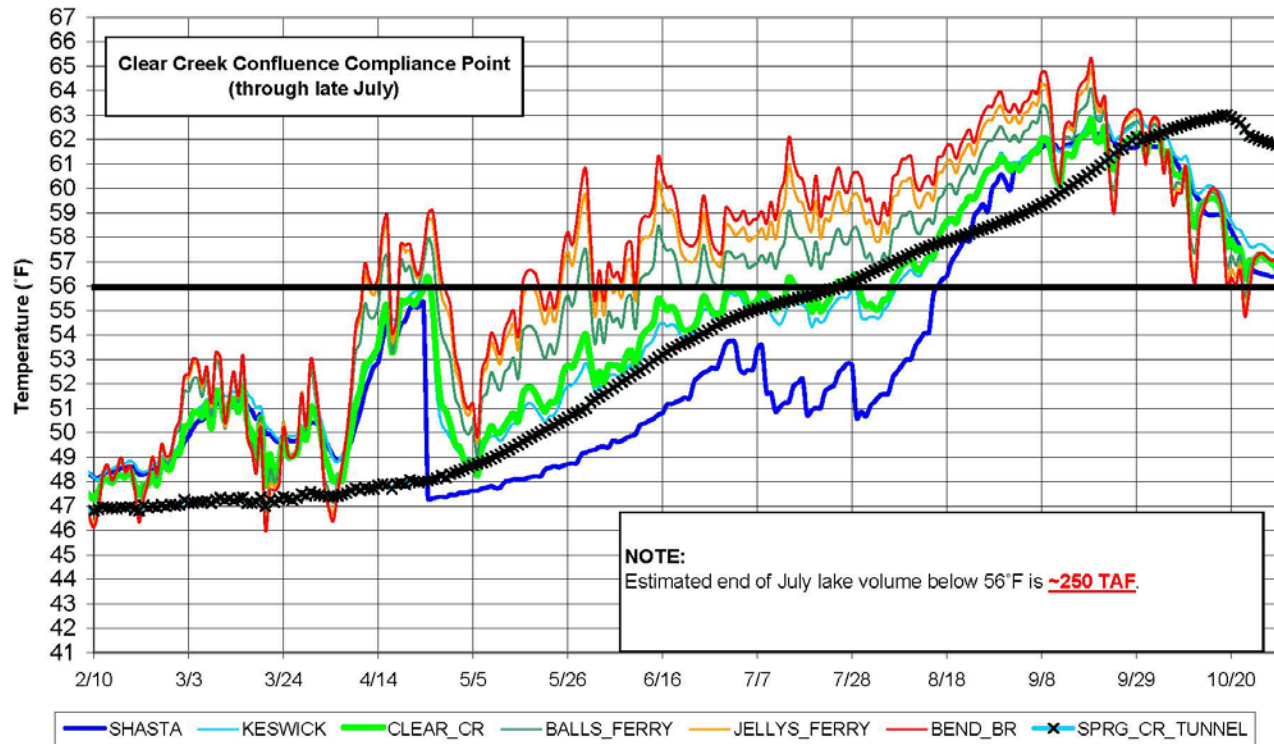
Sacramento River Modeled Temperature
2014 February 90%-Exceedance Outlook

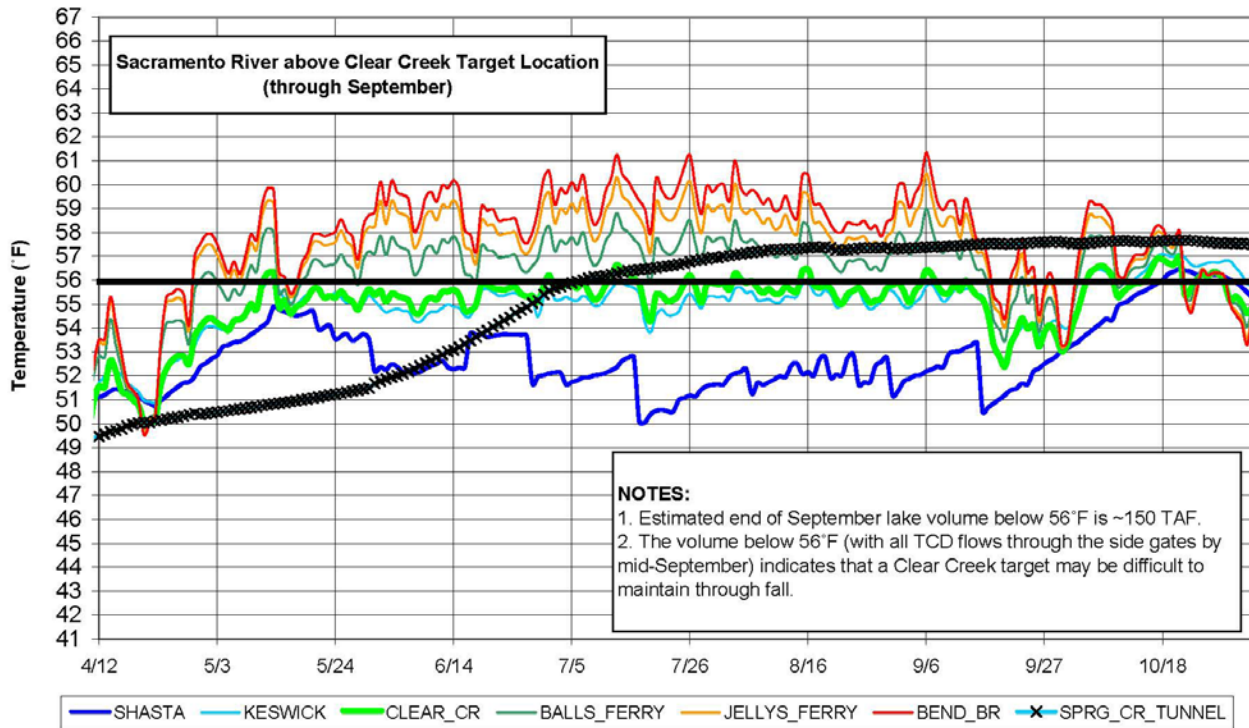
Sacramento River Modeled Temperature 2014 April 90% -Exceedance Outlook

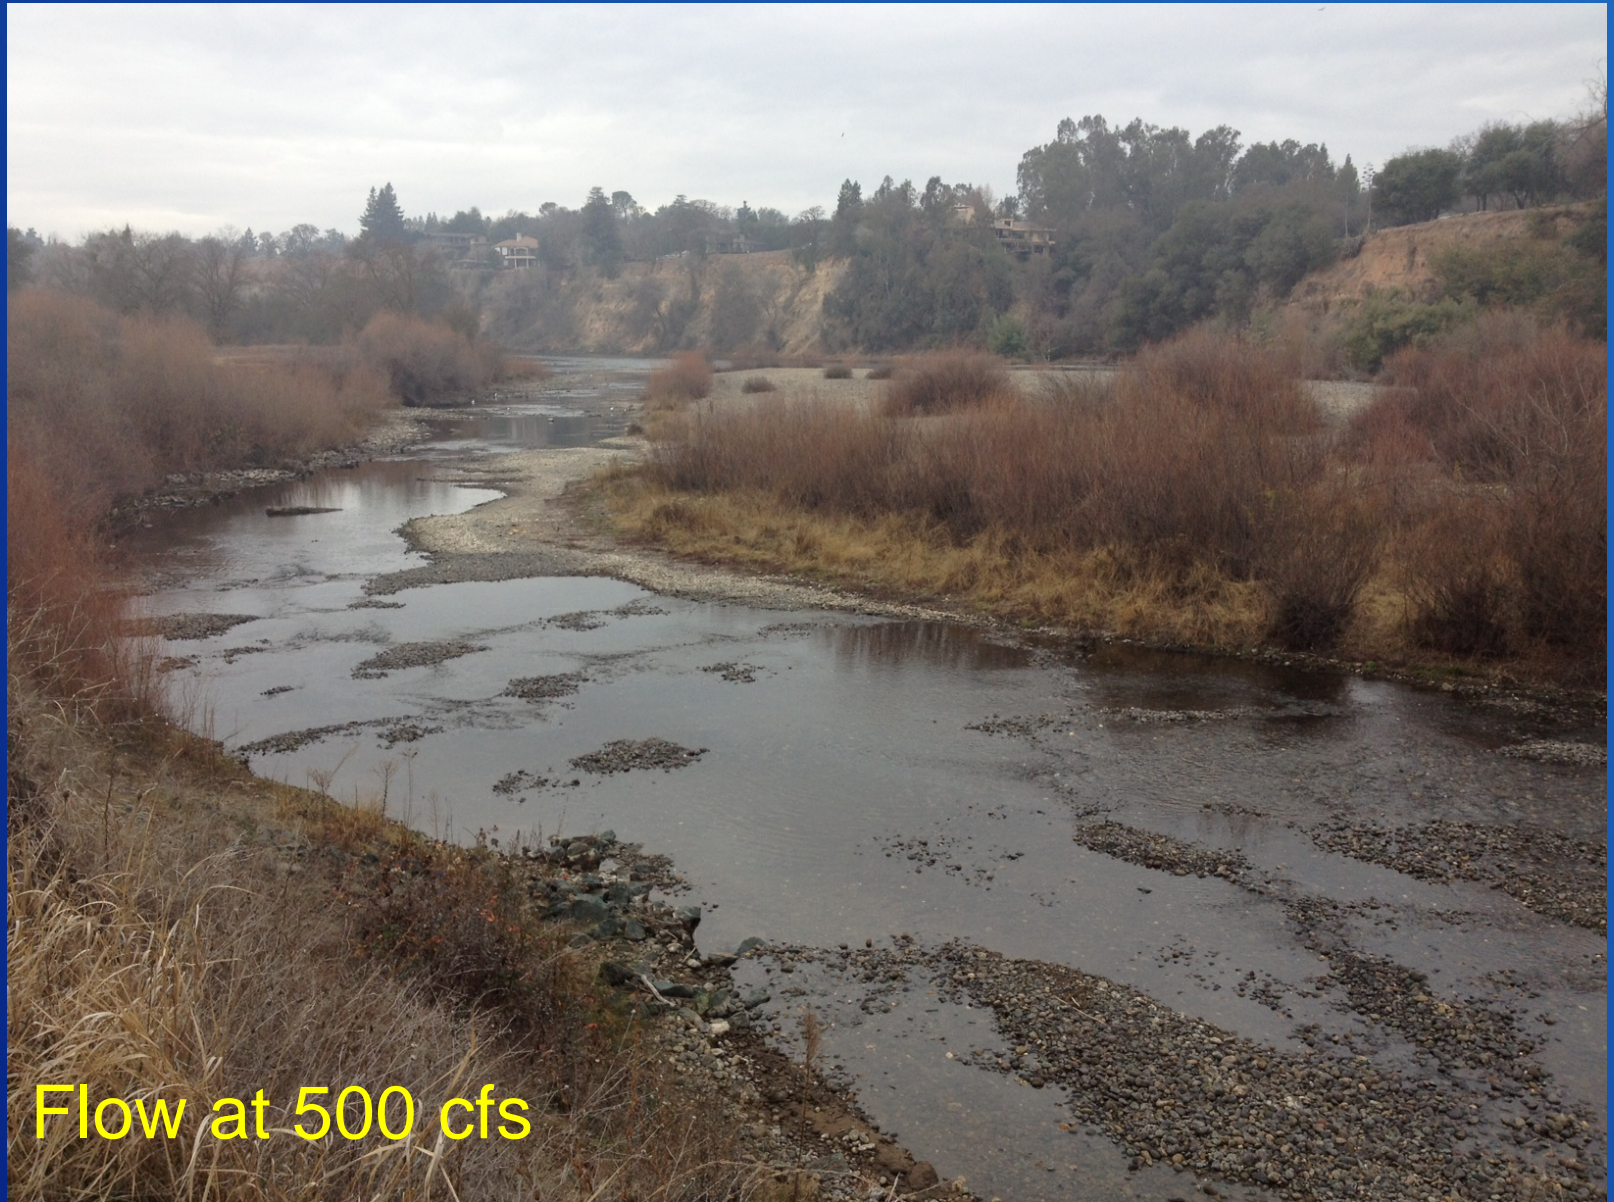
Flow at 500 cfs

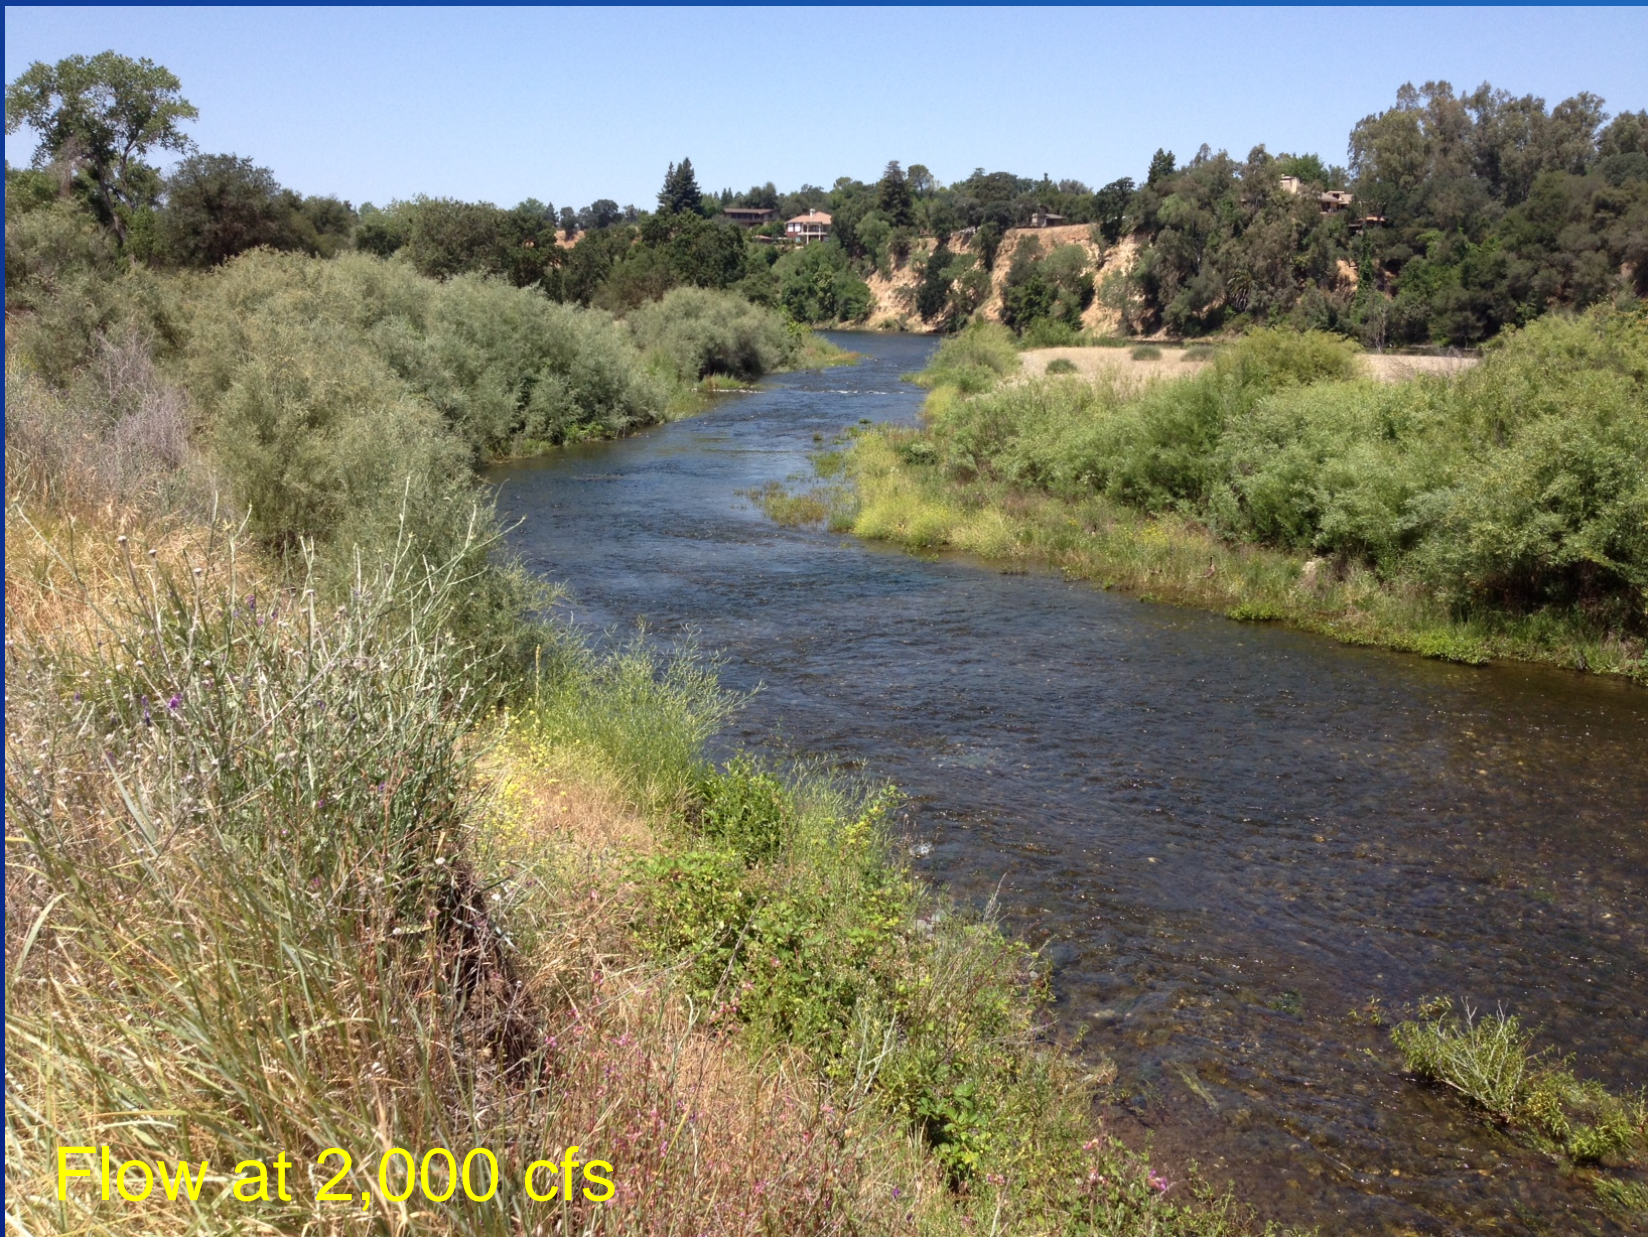
Flow at 2,000 cfs

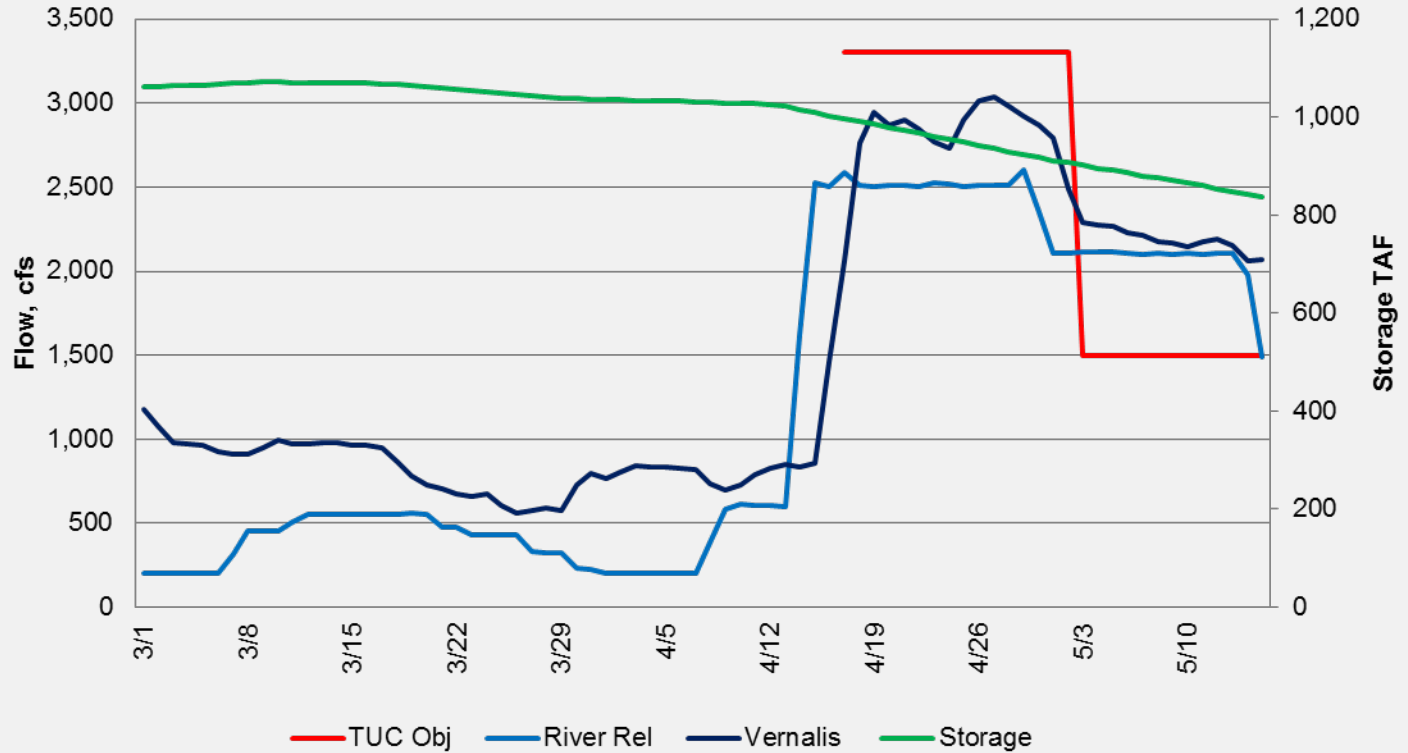
New Melones Reservoir
