Paradise Irrigation District

Camp Fire Update

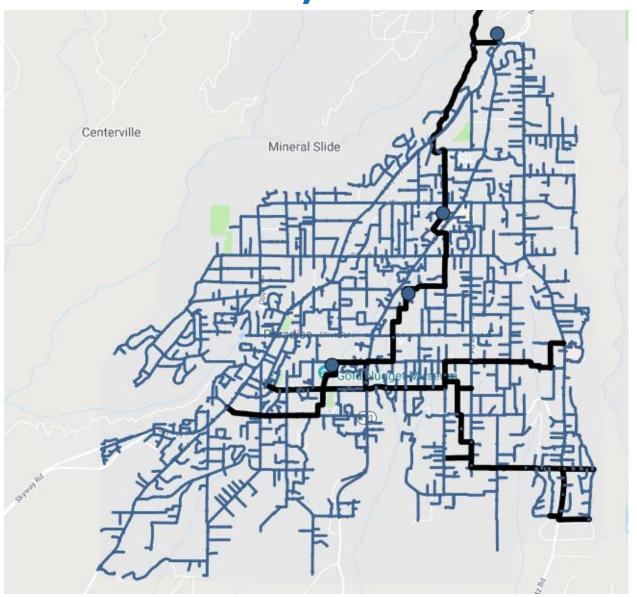
Distribution System

- 172 miles of water main
 - C-900 52 miles
 - C-905 1.25 miles
 - Steel 58 miles
 - CML 33 miles
 - ACP 17.25 miles
 - Galv. 2.5 miles
 - PVC 7.3 miles (schedule 40 and 80)
 - Other 1 mile
- 7 pressure zones A G
- 5 storage tanks
 - 1 in ground bladder reservoir (B-Res) DESTROYED
 - 4 aboveground steel storage tank (A, C, D, and E)

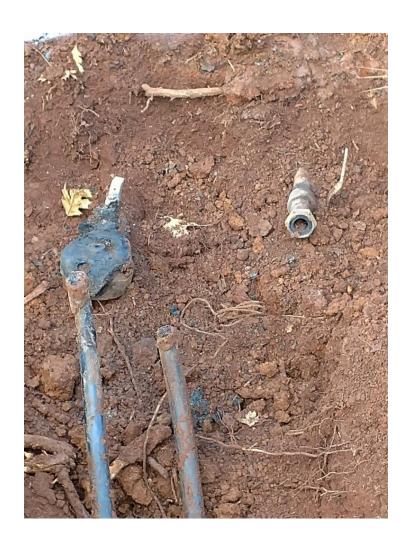
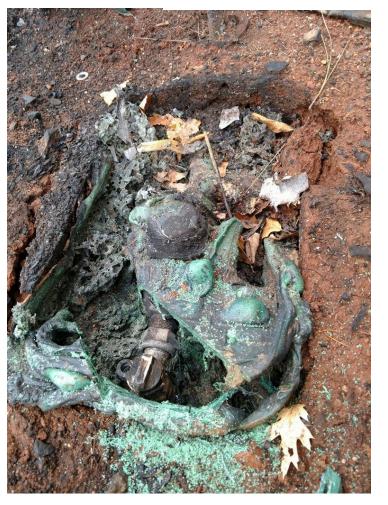
Burnt Meters And Contamination

- Depressurization Created a Vacuum
- Contamination
 - Burnt Plastics
 - Meters
 - Service Lines
 - Homes
 - Irrigation
- VOC's (Volatile Organic Compounds)
 - Benzine (DDW mcl 1 part per billion)
 - Other Contaminates
- Contamination is located in distribution infrastructure

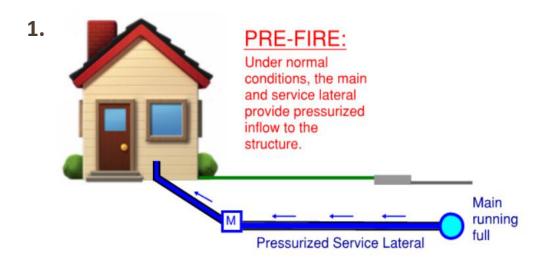
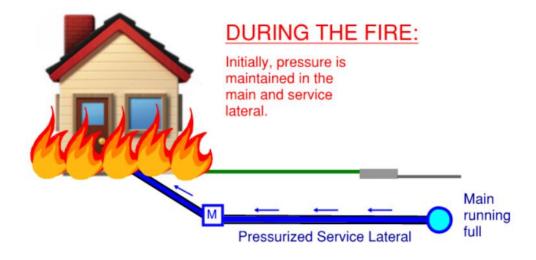
Depressurization of the System

DURING THE FIRE:

The water main loses pressure, resulting in negative pressure in the service lateral. Smoke and debris are sucked into the pipe.

Mains empty due to open system and firefighting efforts

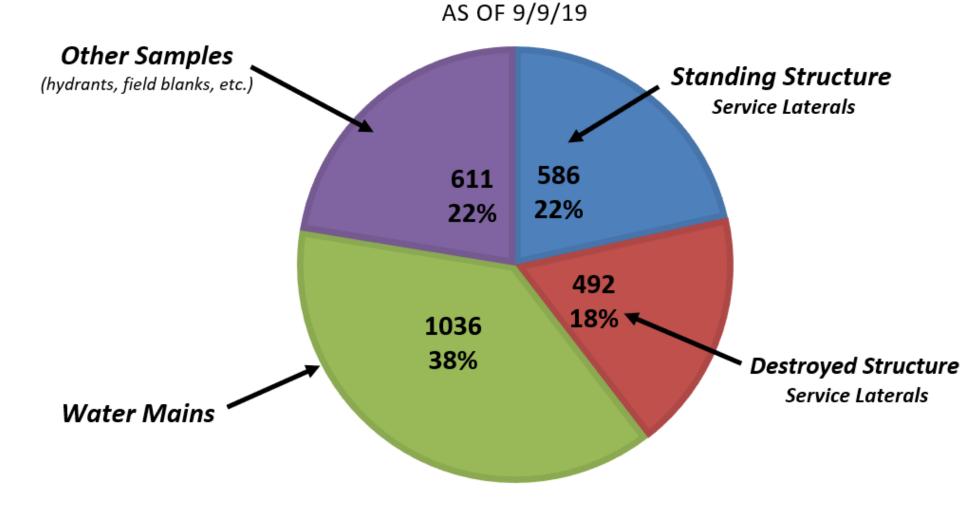
SAMPLE LOCATION BREAKDOWN

- Approx. 2725 samples to date
- Mainline samples show some signs of contamination
- 46% of tested service lines of burnt lots have a detection of a fire related VOC
- 30% of the burnt lots have contamination over the state MCL
- Benzene & Other VOC's
 - Benzene Average: 31 ppb
 - Benzene Low o.5 ppb high 923 ppb
 - Other fire related VOC's have been detected in the water system without the presence of benzene

2,725 sites sampled

Over 200,000 tests performed

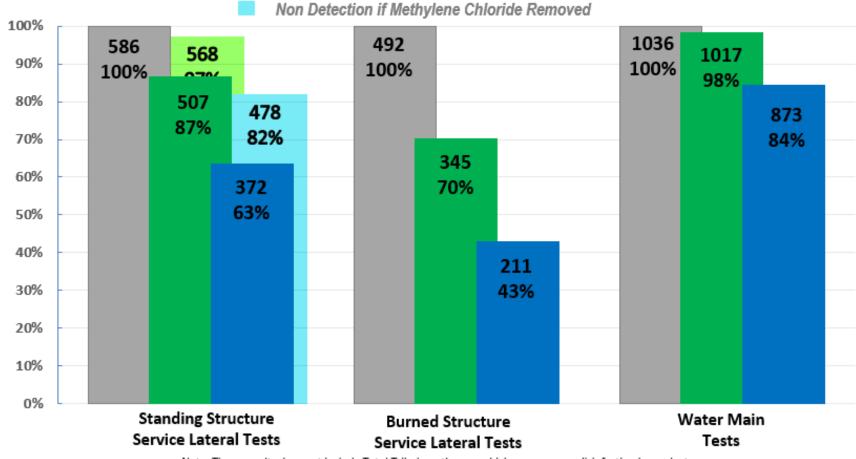
Sampling Summary Results (as of 9/9/19)

What does the current data show?

■ Total Tests ■ Meets Regulations ■ Non Detection

Meets Regulations Excluding Methylene Chloride

Note: These results does not include Total Trihalomethanes, which are common disinfection byproducts
