Iron Mountain Mine Superfund Site

Site History, Cleanup, and Current Status
October 2015

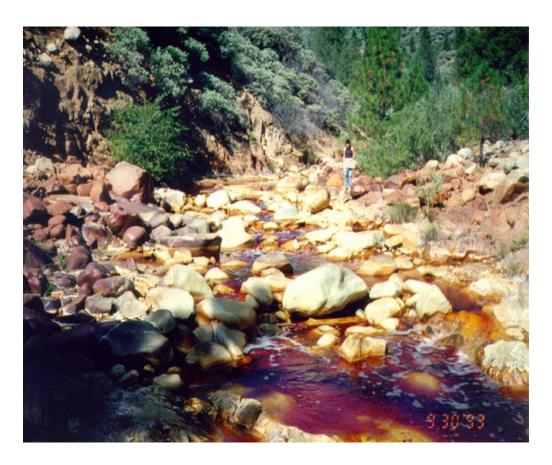
Impacts to Spring Creek (pH = 3)

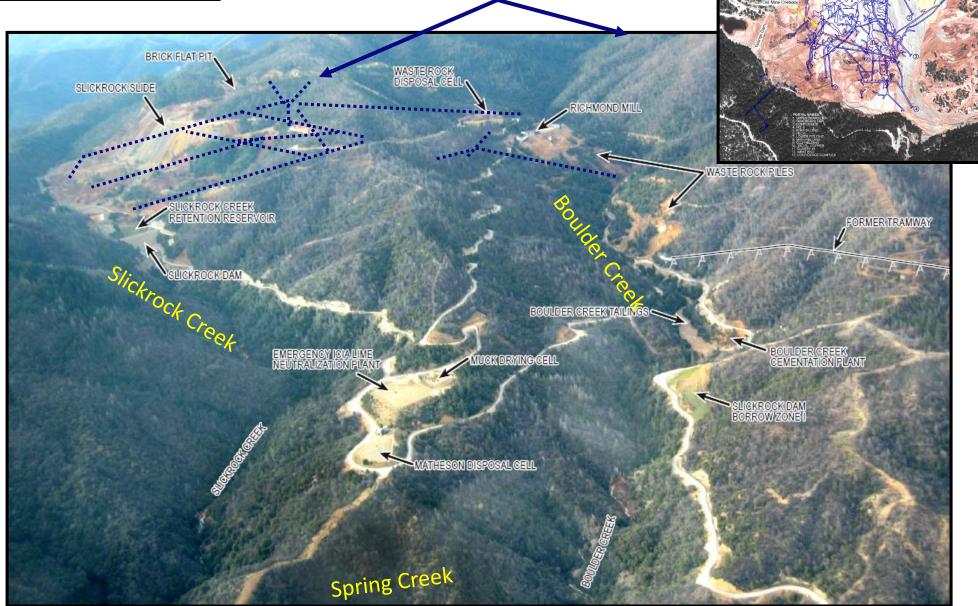
Main Mine Area of Iron Mountain Mine

Adits in the mine workings

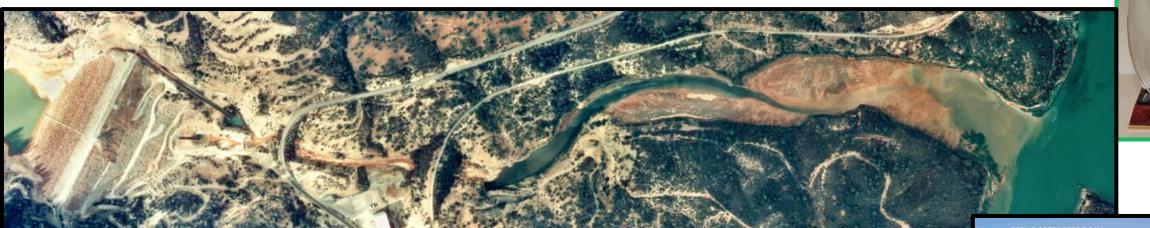
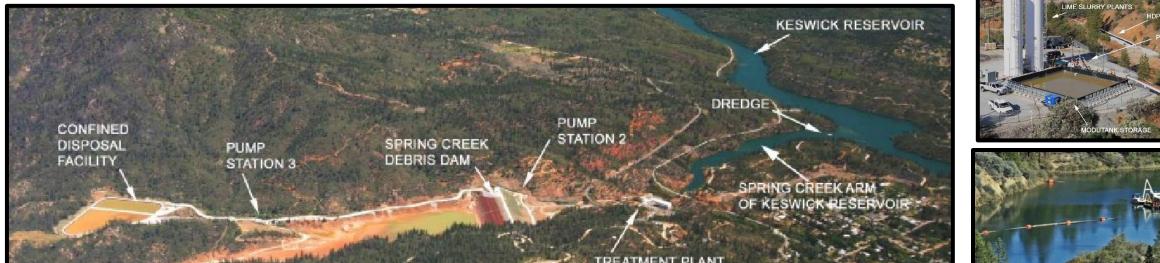
Spring Creek Arm of Keswick Reservoir Dredging Project
